NAVAL BIODYNAMICS LABORATORY  
NBDL-91R003

## HUMAN FACTORS ASSESSMENT OF USCG 47-FT MOTOR LIFEBOAT

Technical Report

October 1991

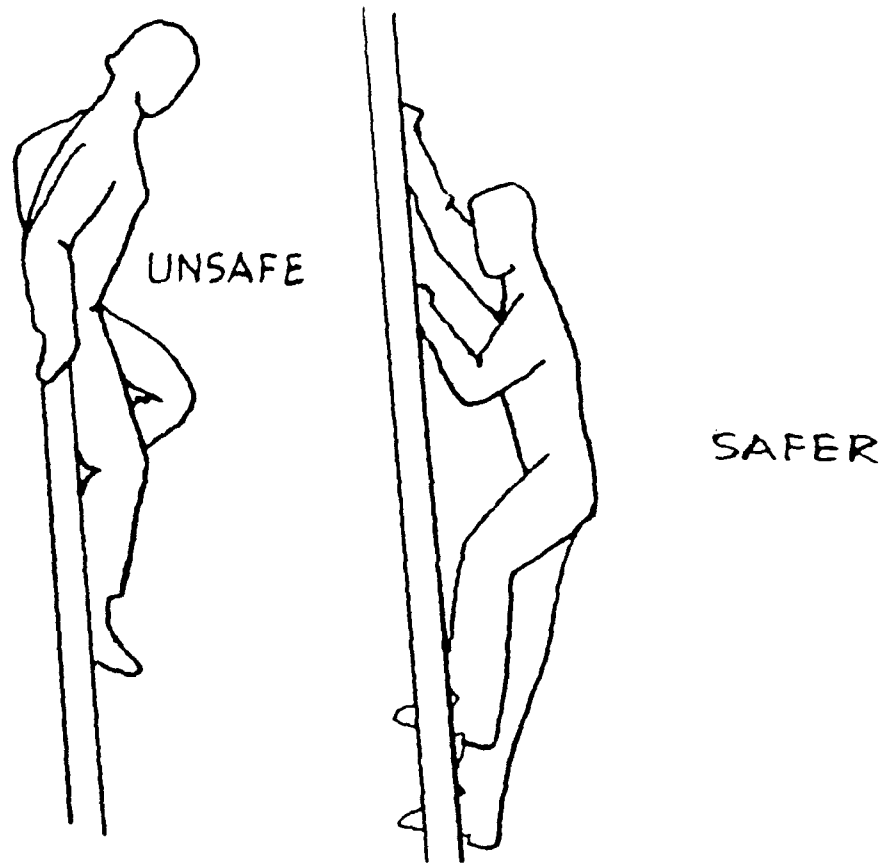
- If the steps are wet, a slipping/falling hazard exists.

Figure I.2. Appropriate and inappropriate ways of descending a ladder.

- Provide a safety screen behind the ladder (steps) to prevent slipping between the steps.
- Curb or round off the aft deck step to prevent crew from tripping "up" the ladder/steps. Aft platform should be flush with the end of the riser, thereby eliminating the tripping hazard.
- The "lips" of the deck meet the grating of the recessed deck. However, the end of the grating deck should be extended and closed, if possible.
- Install a railing on the bulkhead just below the recessed deck grating in order for crew to brace themselves in a kneeling position while recovering overboard people or objects.
- This railing should extend 4 inches from the bulkhead for hand clearance; the railing would also afford more flexibility than the "D" ring restraints; top of aft platform is a knife edge.

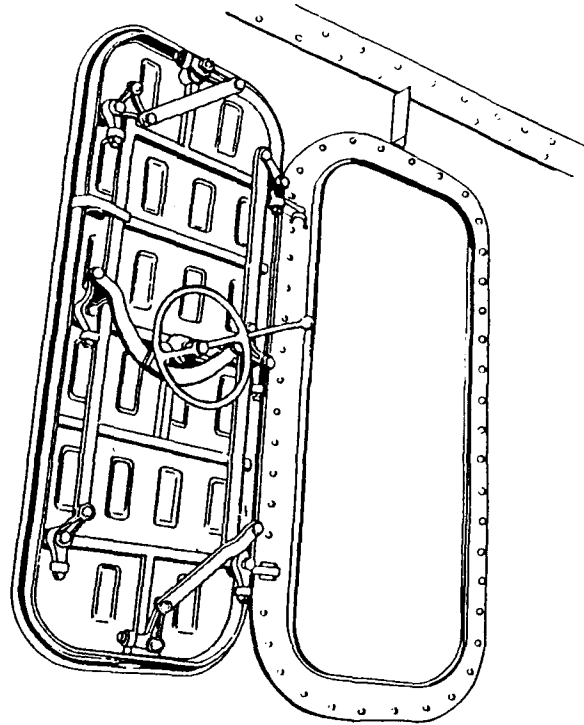
- The door impedes the movement of the port OB chair.
  - The bolts of the door are exposed and present a hazard to the crew passing through the door. Crewmembers have reported minor injuries due to these bolts.

Figure I.3. Watertight door with control wheel, extended handle, and dogs.

- Approach:**
- The door should be designed with a self-locking mechanism to secure the door in an open position. This mechanism is recommended for all doors.

- Grab handles should be placed over the doors and on both sides of the door.
  - Additional positive control of the door can be gained by installing a handhold/grip on both sides. Currently, crewmembers are required to open the door and hold it open (with the dog handle) while climbing up the ladder.

- Recess, cap, or remove threads from the end of the bolts to eliminate the workspace hazard.

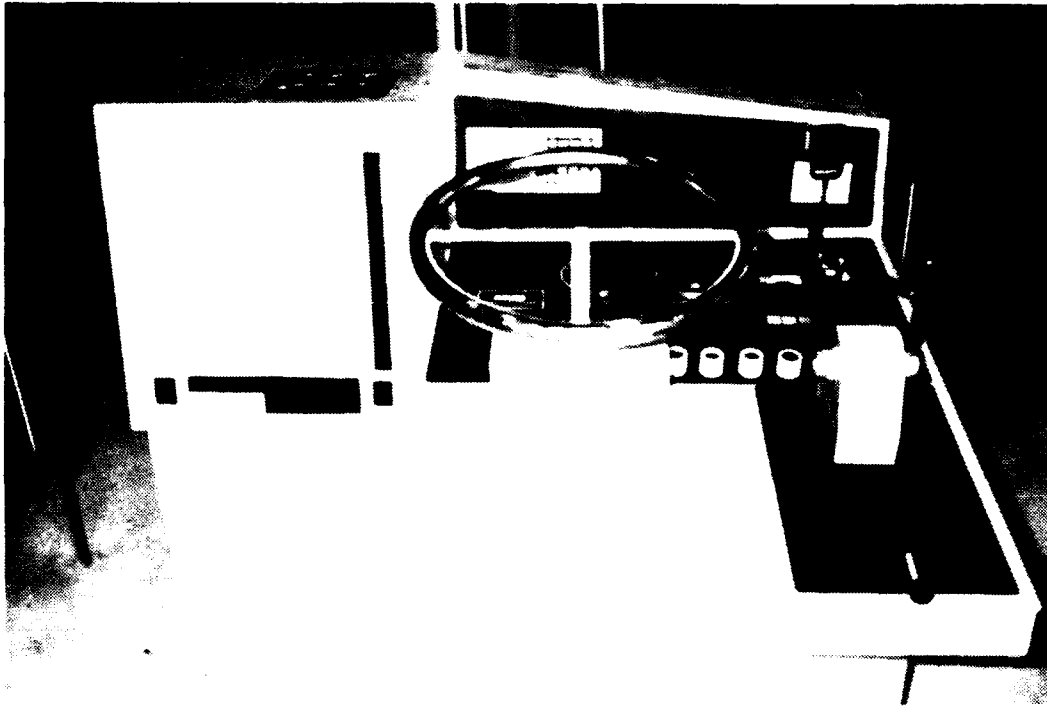
**Figure II.1a.** Current starboard steering station on open bridge.

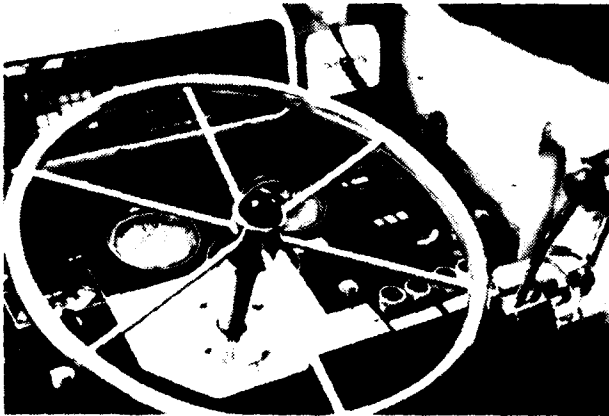
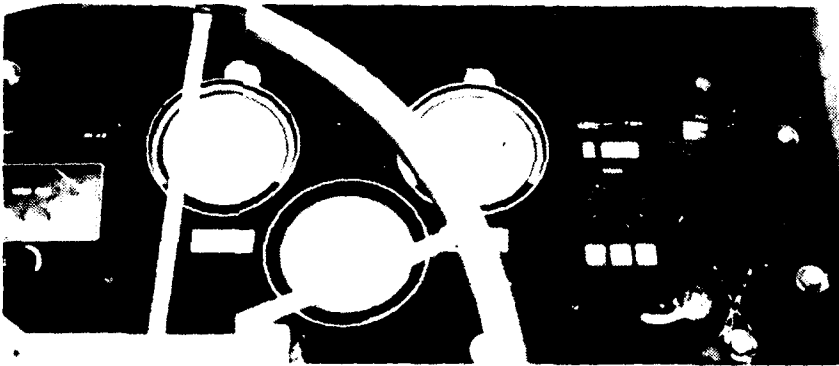
addition, the fathometer, digital compass, and autopilot control are obstructed by hand microphone coiled cords (see Figures II.2a and II.2b). HFE guidelines recommend not placing one control or display behind another, which requires operators to reach around or shift equipment to see the display or manipulate the control.

- The autopilot control and fathometer displays accumulate internal moisture and compromise the view of the operator.
- The navigation light switch panel is located on the radar plotter screen enclosure.
- The wet compass is not located on the centerline.

Figure II.2a. Current starboard steering station on open bridge.

Figure II.2b. Current starboard steering station open bridge/dials.

- Display units should be completely water and shockproof and should be filled with dry nitrogen to prevent fogging and internal corrosion.
- Relocate the wet compass to the centerline.
